**US Army Corps
of Engineers®**
Engineer Research and
Development Center

Fluvial Instability and Channel Degradation of Amite River and its Tributaries, Southwest Mississippi and Southeast Louisiana

D. Ryan Hood, David M. Patrick, and Maureen K. Corcoran

September 2007

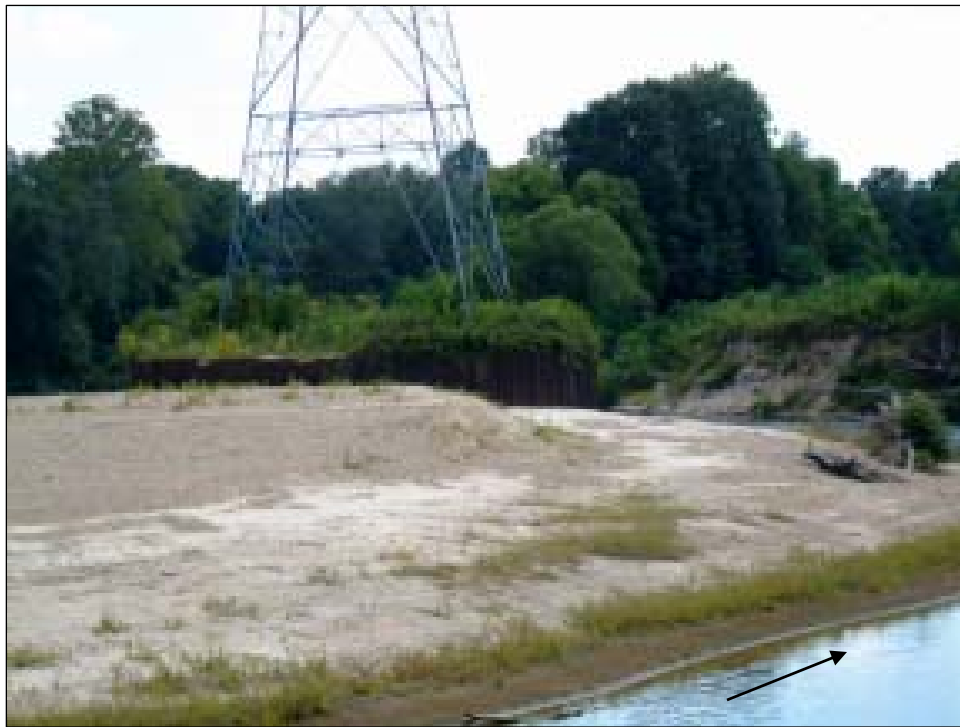
Figure 31. Power transmission pylon at the Louisiana Hwy 432 crossing of the Amite River near Felixville, LA (view downstream—September 2003) (arrow notes flow direction). Note the terrace effect on the point bar.

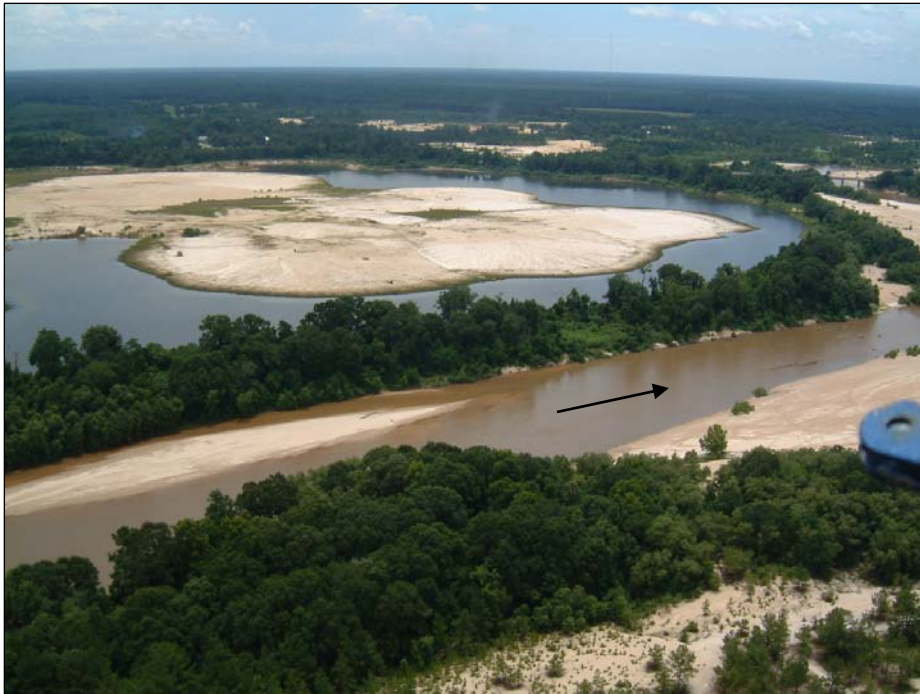
Figure 38. Large abandoned gravel mine on the left bank of the Amite River just upstream of the Louisiana Hwy 37 crossing near Grangeville, LA (arrow notes flow direction—July 2004)

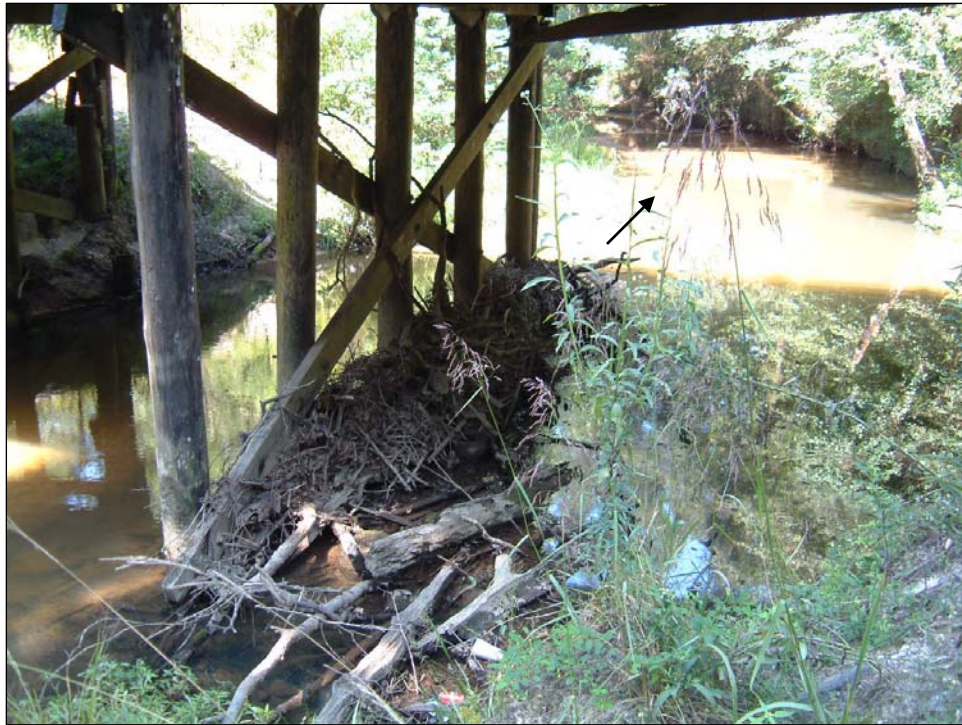
Figure 57. Debris jam at the Louisiana Hwy 38 crossing of Darling Creek near Darlington, LA (arrow notes flow direction—September 2003).

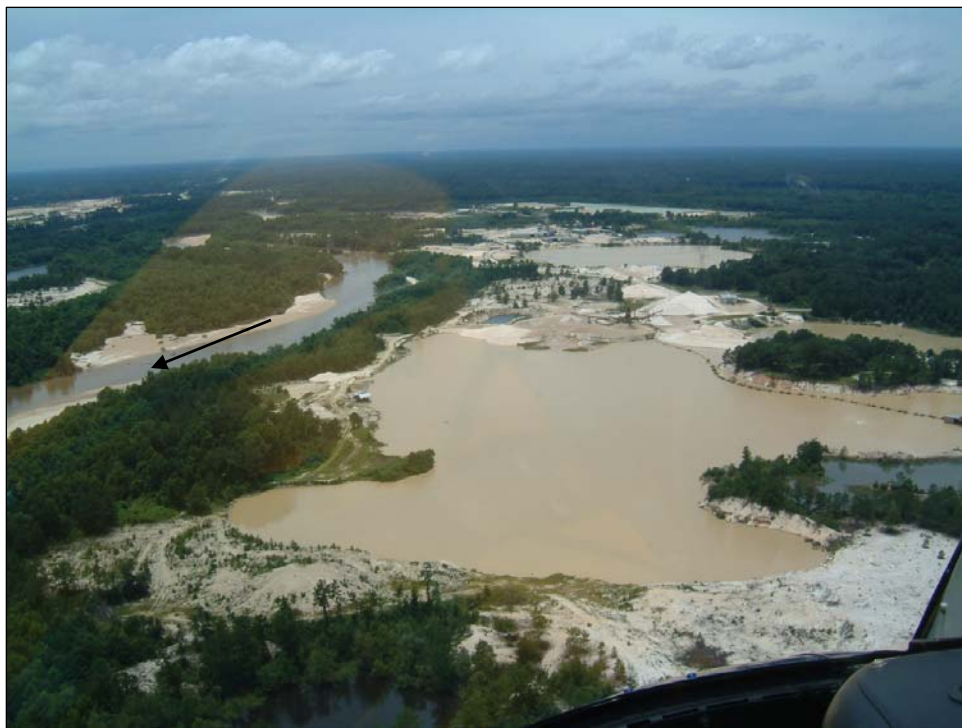
Figure 58. Large gravel mine on right bank of the Amite River near Magnolia, LA (arrow notes flow direction—July 2004).

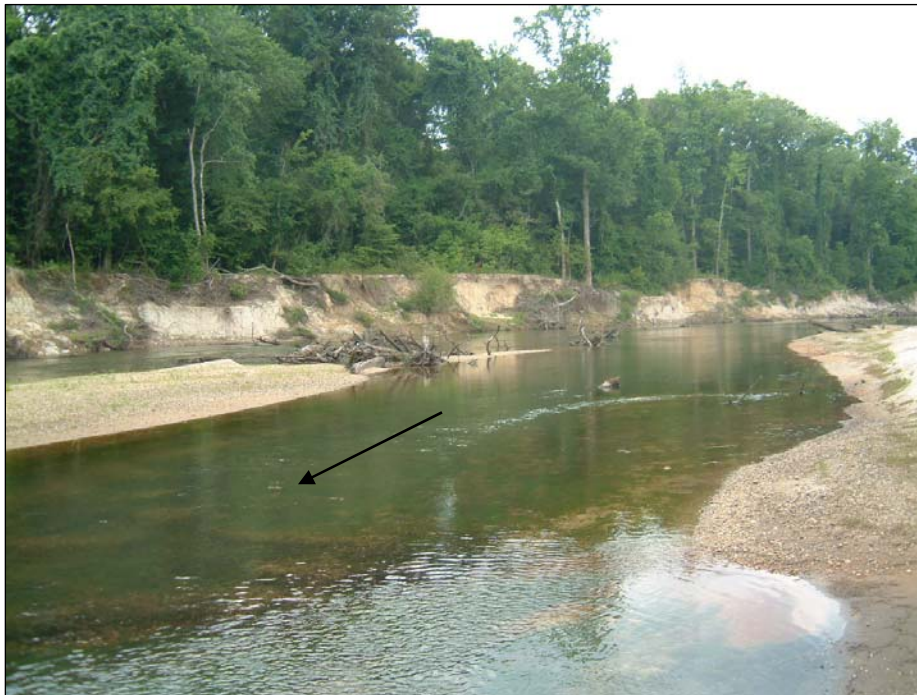
Figure 67. Upstream view of the Amite River adjacent to active gravel mine near Magnolia, LA (note steep, eroding banks and divided flow conditions—June 2003) (arrow notes flow direction).

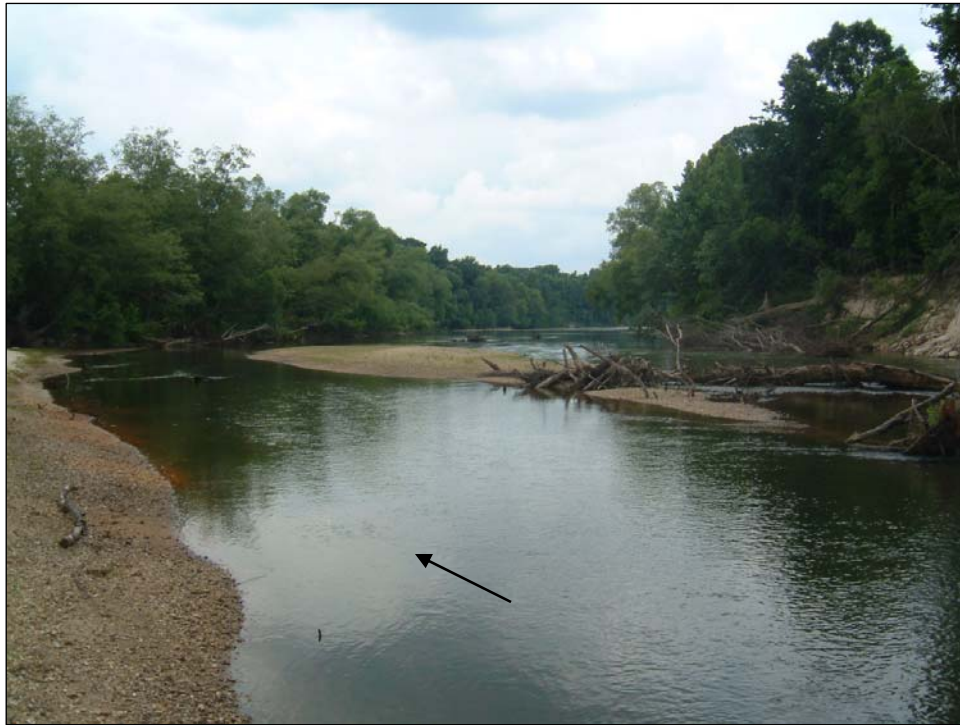
Figure 68. Downstream view of the Amite River adjacent to active gravel mine near Magnolia, LA (note divided flow conditions and debris in the channel—June 2003) (arrow notes flow direction).

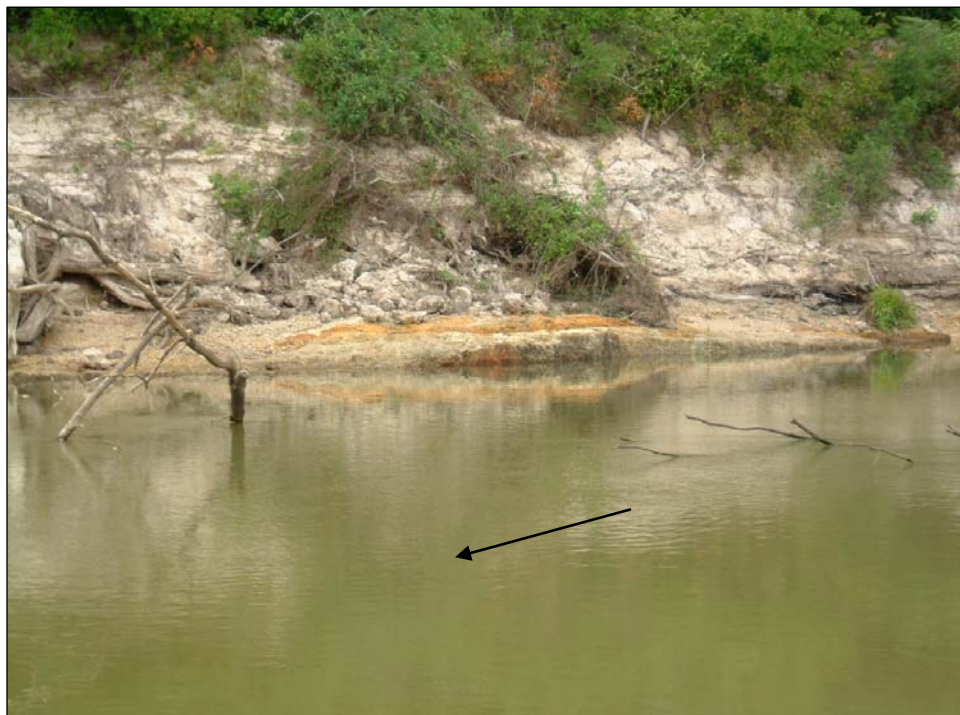
Figure 69. Steep, eroding right bank exhibiting a reddish-brown lens or zone near the waterline adjacent to active gravel mine near Magnolia, LA (arrow notes flow direction—June 2003).

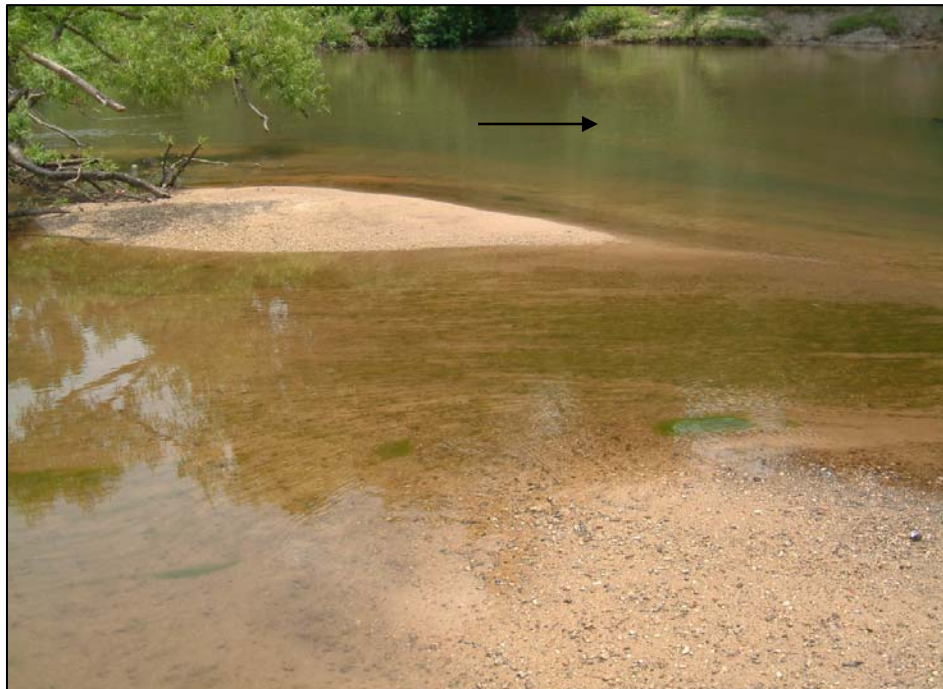
Figure 78. Sand and gravel bar in the Amite River channel at the Louisiana Hwy 64 crossing near Magnolia, LA (arrow notes flow direction—June 2003).

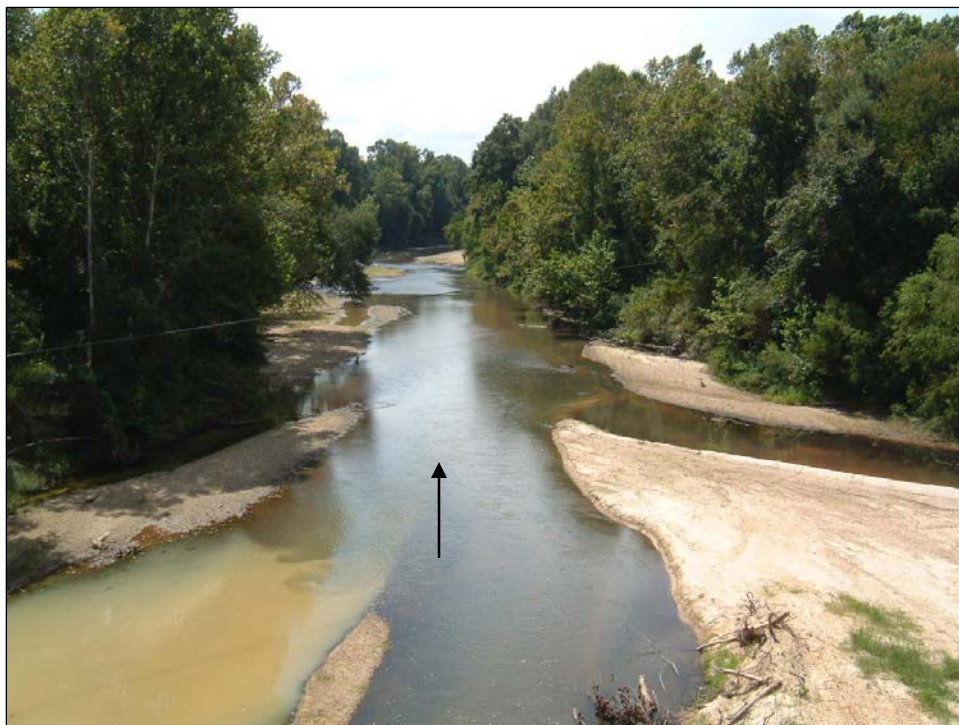
Figure 92. Downstream view of the Comite River at the Louisiana Hwy 67 crossing near Olive Branch, LA (note divided flow conditions—July 2004) (arrow notes flow direction).
